# PHENIX WEEKLY PLANNING

TECHNICAL  
SUPPORT  
NO--

6/23/2011  
Don Lynch

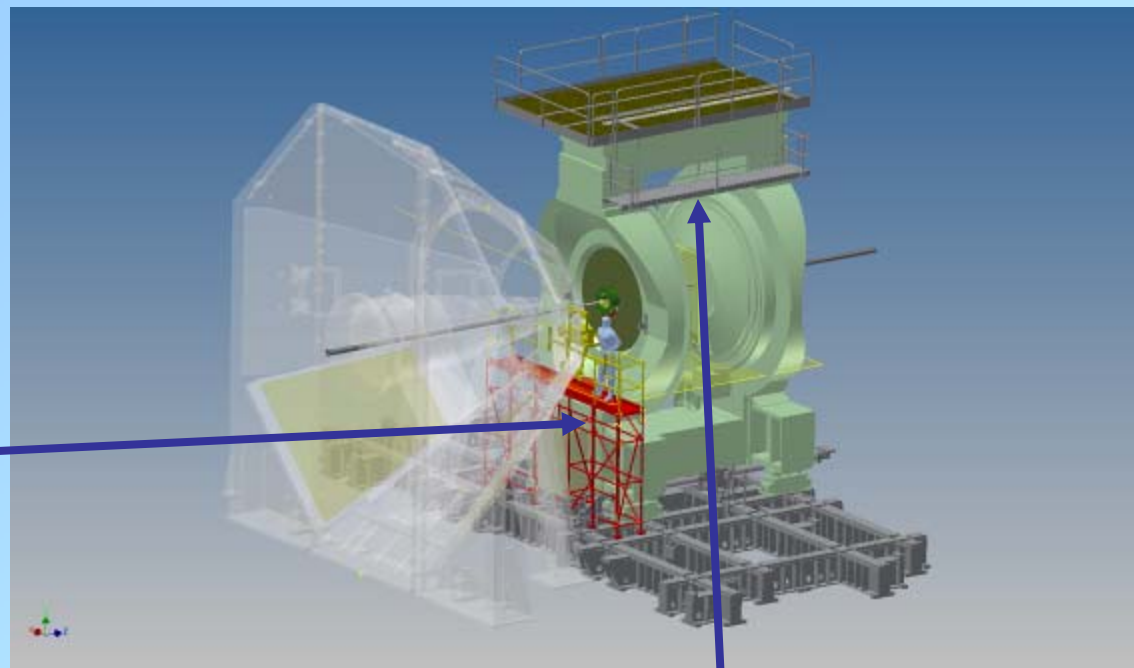
Station 1 platform configured for lower level access shown with North Muon Magnet in phantom for reference and invisible for clarity.

Central Magnet suspended work platform also shown in both models.

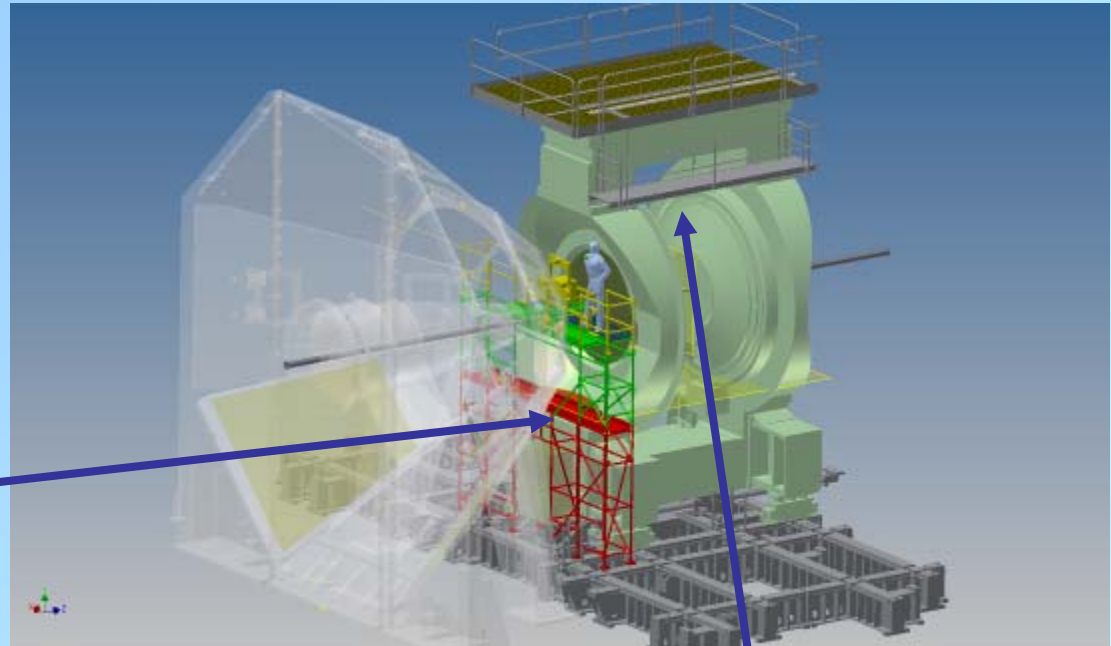
Station 1 platform configured for upper level access shown with North Muon Magnet in phantom for reference and invisible for clarity.

Central Magnet suspended work platform also shown in both models.

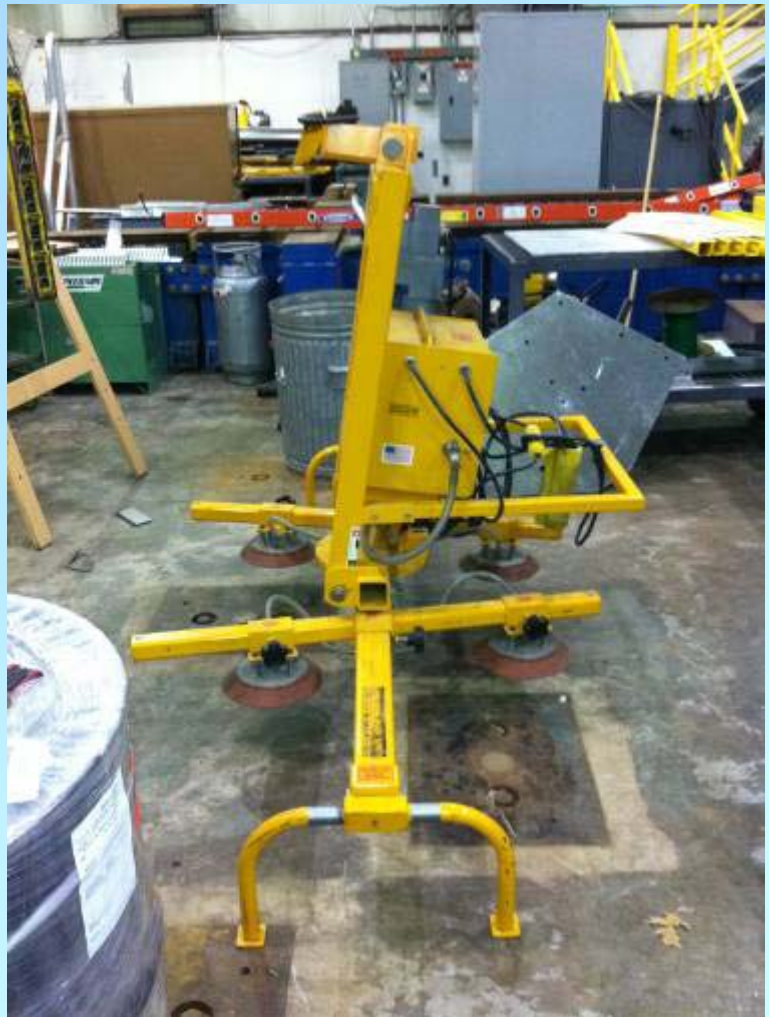
MuTr station 1 lifting fixture  
Re-certification analyses  
submitted to CAD

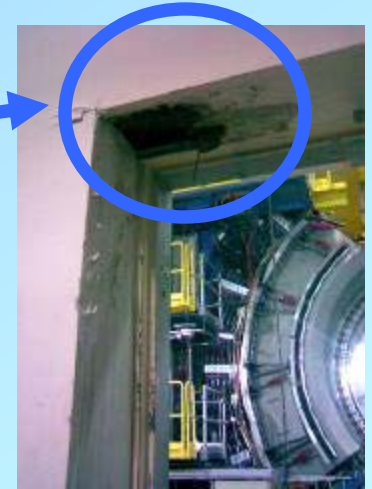
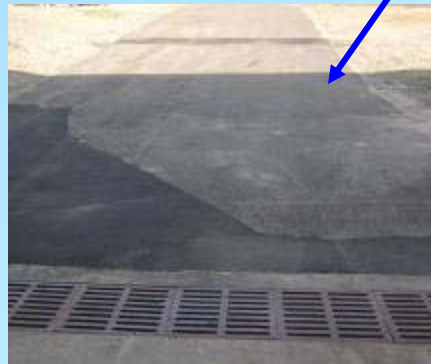
- Roof leaks in utility bathroom at northwest corner behind tech offices, over door between rack room and assembly hall, over door between control room and elect. ass'y room, southeast corner of IR and laser room.
- Flooding in AH/ Driveway heaving
